# VEHICLE INSPECTION REPORT

**YA17SUH**

## Daf LF 150

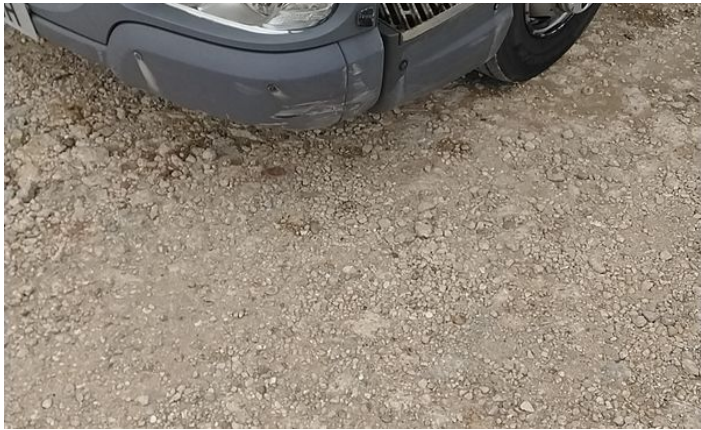
3: Bumper Front  
Scratched  
25 to 100mm Thru Paint
